Tullamarine Landfill

Community Consultation Group

MEETING NOTES

2014 Technical Report for Auditor Review – Tullamarine Closed Landfill

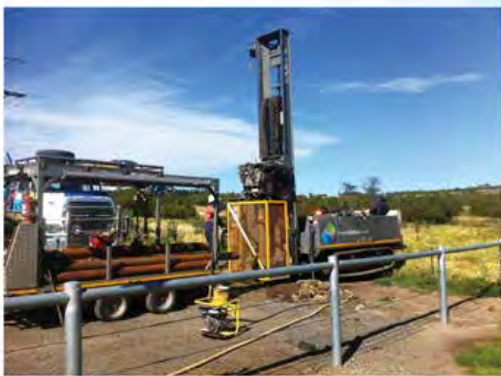
Drilling, 4 November

Community members were invited to watch the drilling process for the new groundwater wells on 4 November 2016. There was a lot of general interest in the geology from the core samples and the engineering required.

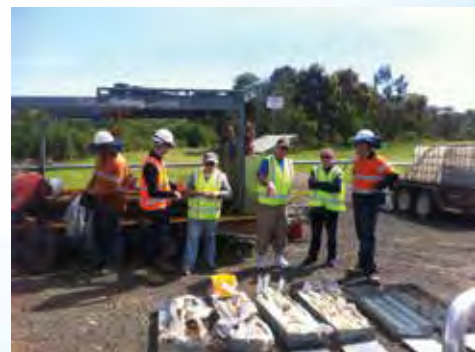
Recovered Drilling Core, 4 Nov

The first borehole drilled was closer to Moonee Ponds Creek and the water table was shallower than elsewhere in Wright St at ~10m. The soil core was found to be from the Werribee Formation and bedrock, which is a different geological formation from many of the other 110 boreholes monitoring the landfill, which are in Volcanic basalt.

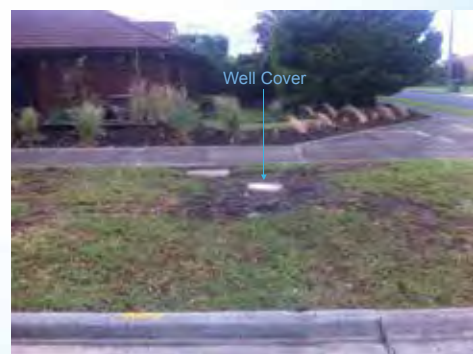
Completed Drill Hole, 14 Nov

The wells have been covered and will be sampled as part of the ongoing sampling program. The data will be brought to TLCCG.

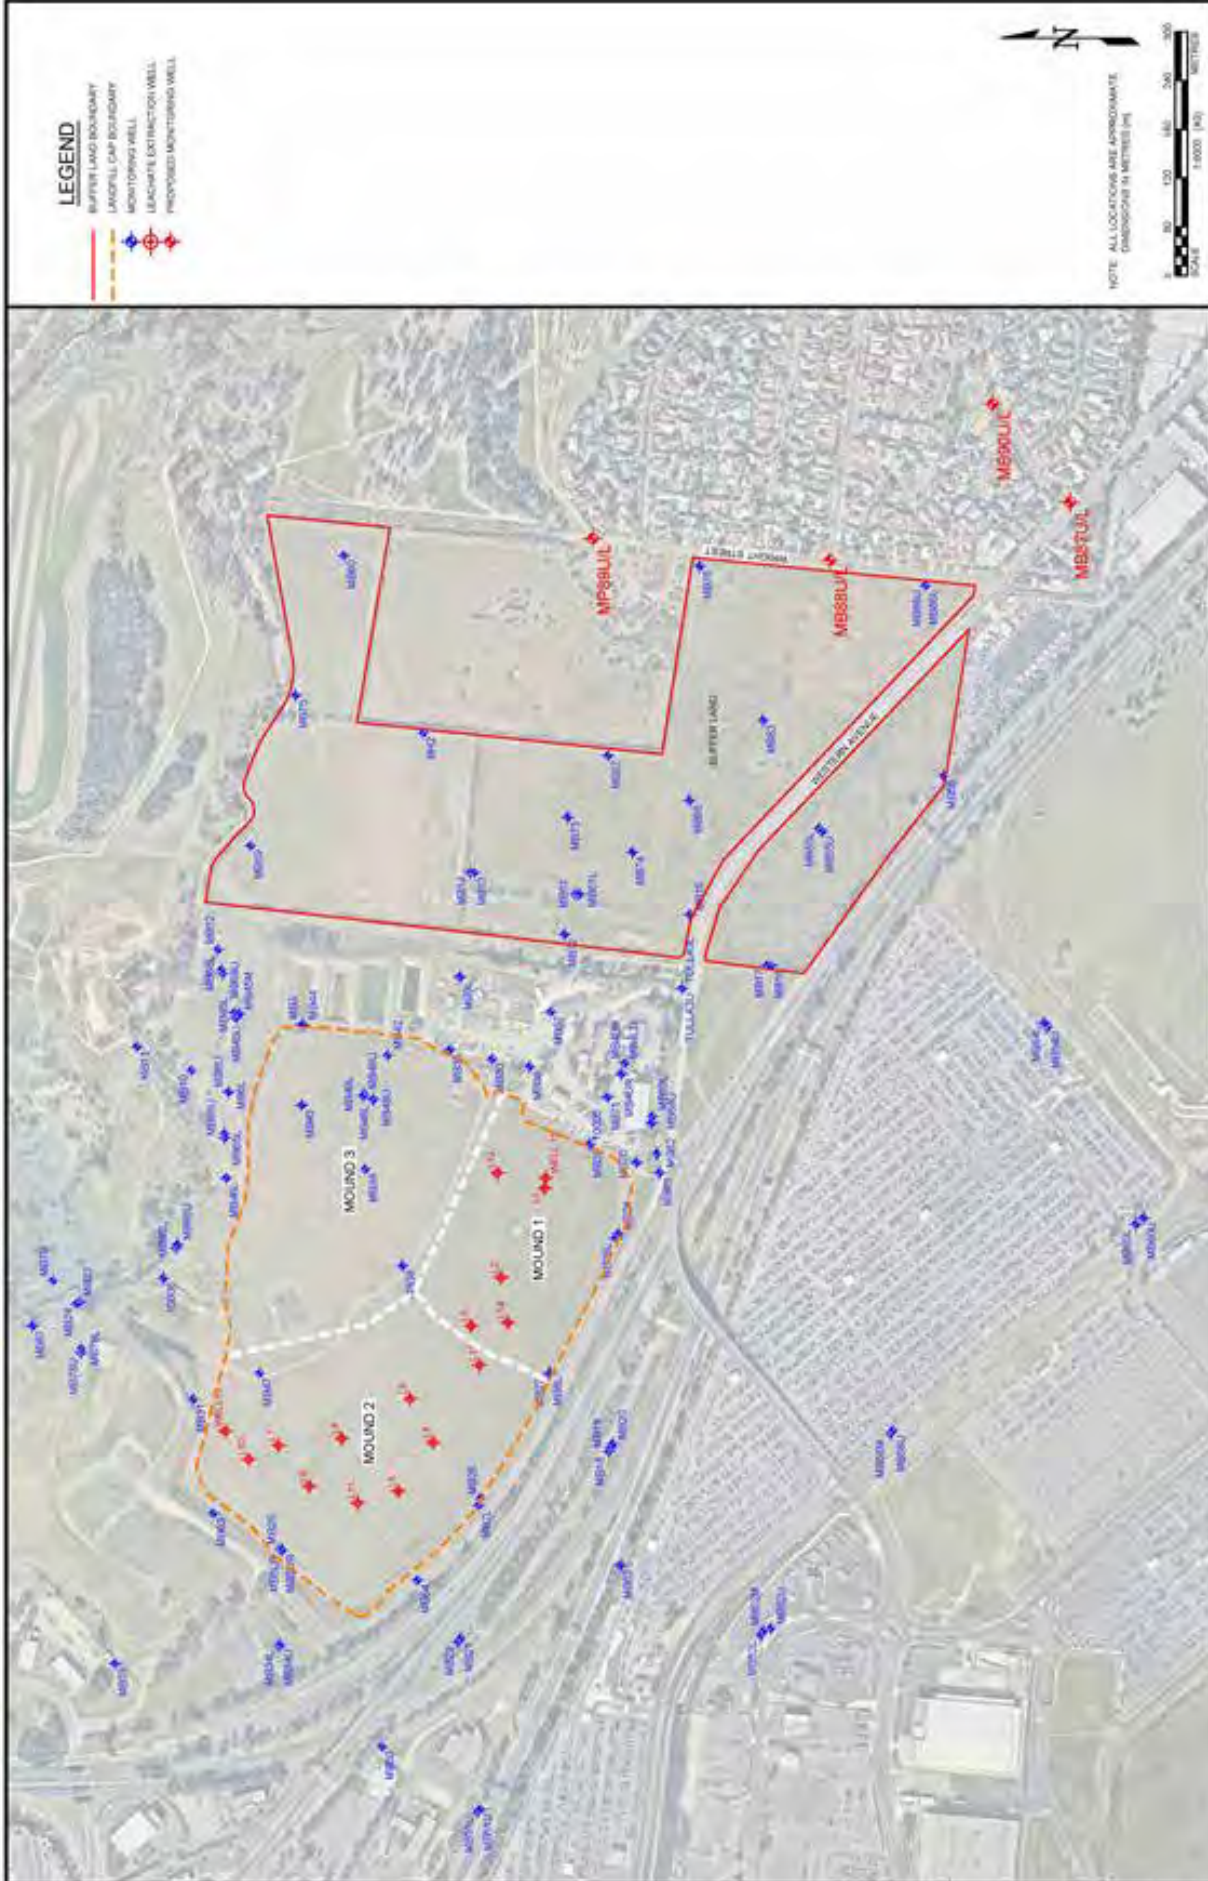
KIEREN: There are four groundwater monitoring wells – Hillcrest Avenue, Western Avenue and two in Wright St.

PROJECT: MP18100.001P DATE DRAWN: 15.01.18 DRAWN BY: LZ CHECKED BY: MH FILE NAME: MP18100.001P.dwg	PROPOSED MONITORING WELL LOCATION PLAN	FIGURE 1
	TCL TULLAMARINE MONITORING WELL INSTALLATION WESTERN AVENUE WESTMEADOWS, VICTORIA

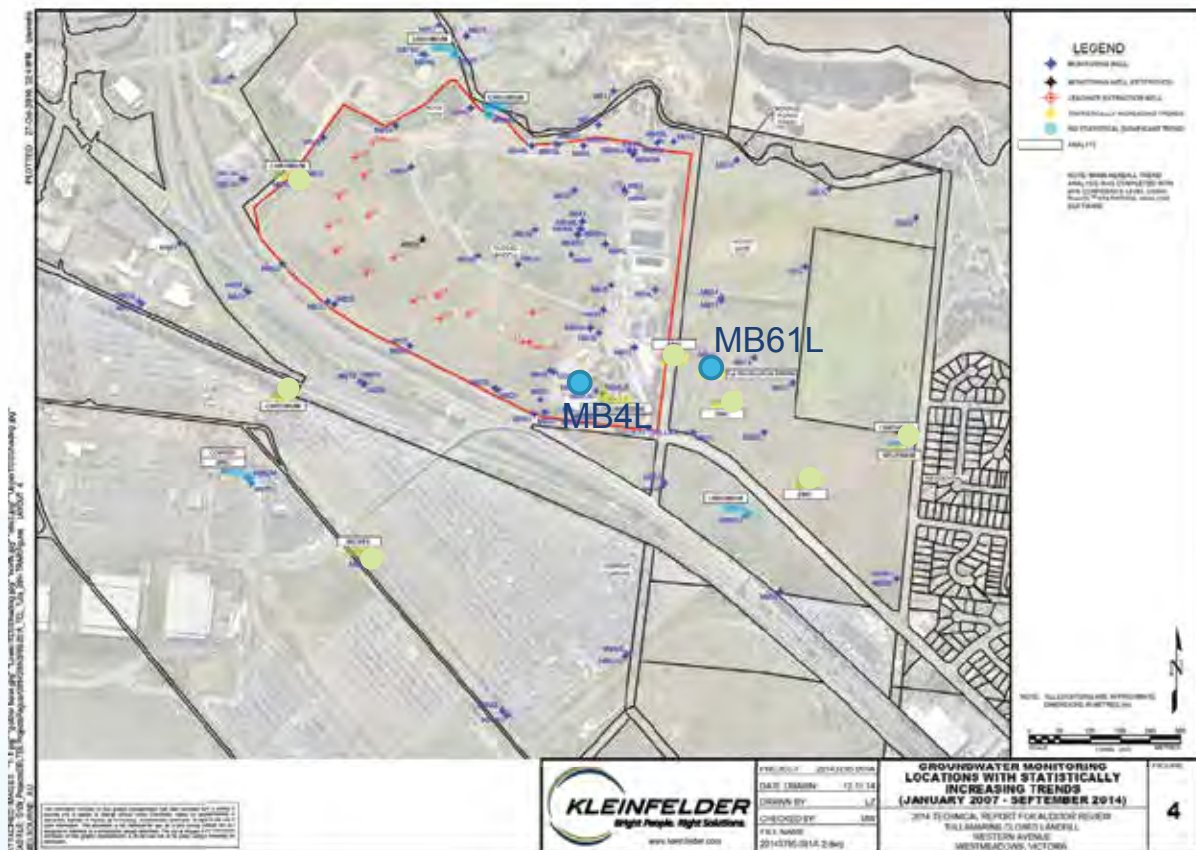
Figure 4 from Kleinfelder Report

Figure 4 highlights the trend anomalies in the levels of metals and hydrocarbons. Yellow dots show an increasing metal trend and blue shows increasing hydrocarbon trends.

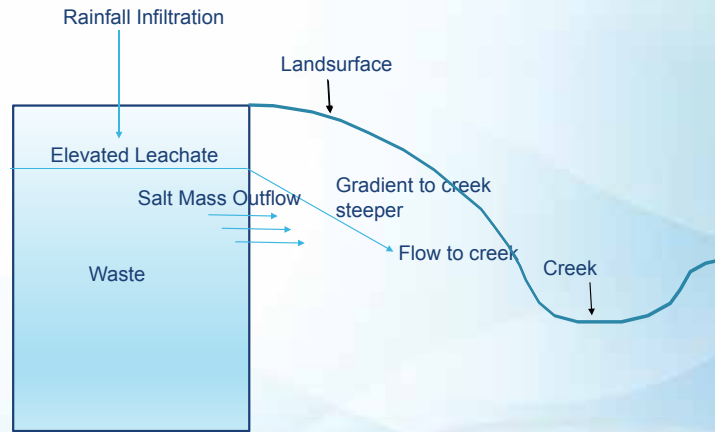
Conceptual Model – Pre Cap

The following three diagrams illustrate the expected model for the landfill leachate and salinity movement over time: before the cap was established, with the cap and in the future.

The waste was initially put into the old basalt quarry without a cap. The leachate sat towards the top of the waste and the salt mass was moving towards the creek. Now the landfill is capped and the leachate level has dropped so there is less mixing and infiltration of water – the leachate level has fallen although the salt is still moving towards the creek. In 2035, it is expected that the leachate will be below the creek water level and the salt will not be moving to the creek.

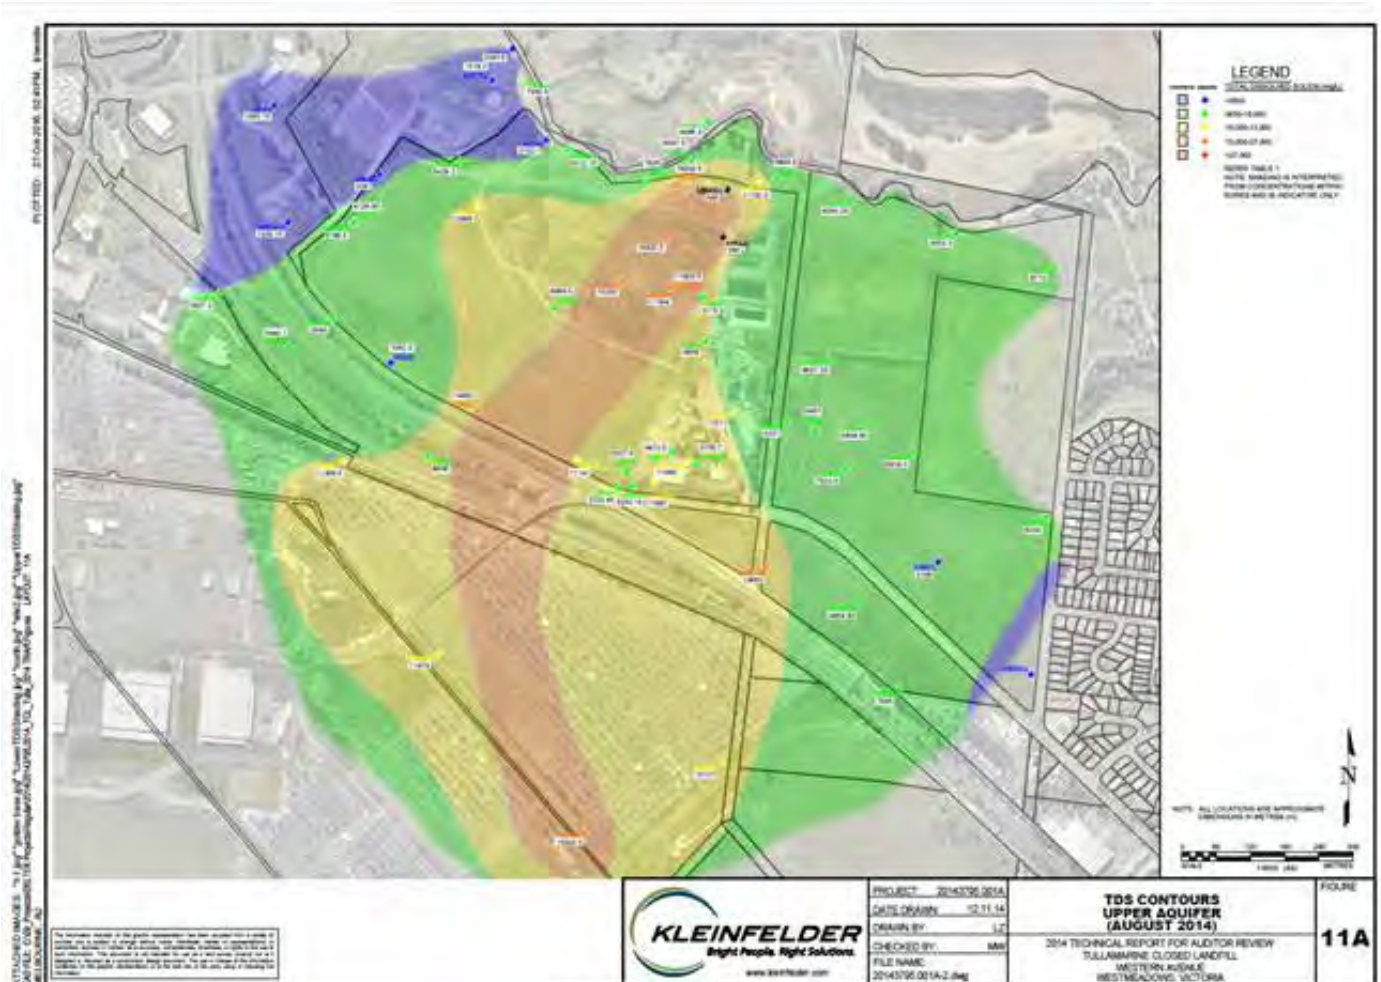
KIEREN: The Kleinfelder TRAR report Figure 11A shows what is happening to the salt (see below). The salt is heading towards the airport (away from the creek) in the water table aquifer. This correlates with what we are finding but it does not yet provide proof because levels in the landfill need to fall a bit further.

COMMENT: *The salt is still heading towards Steele Creek!*

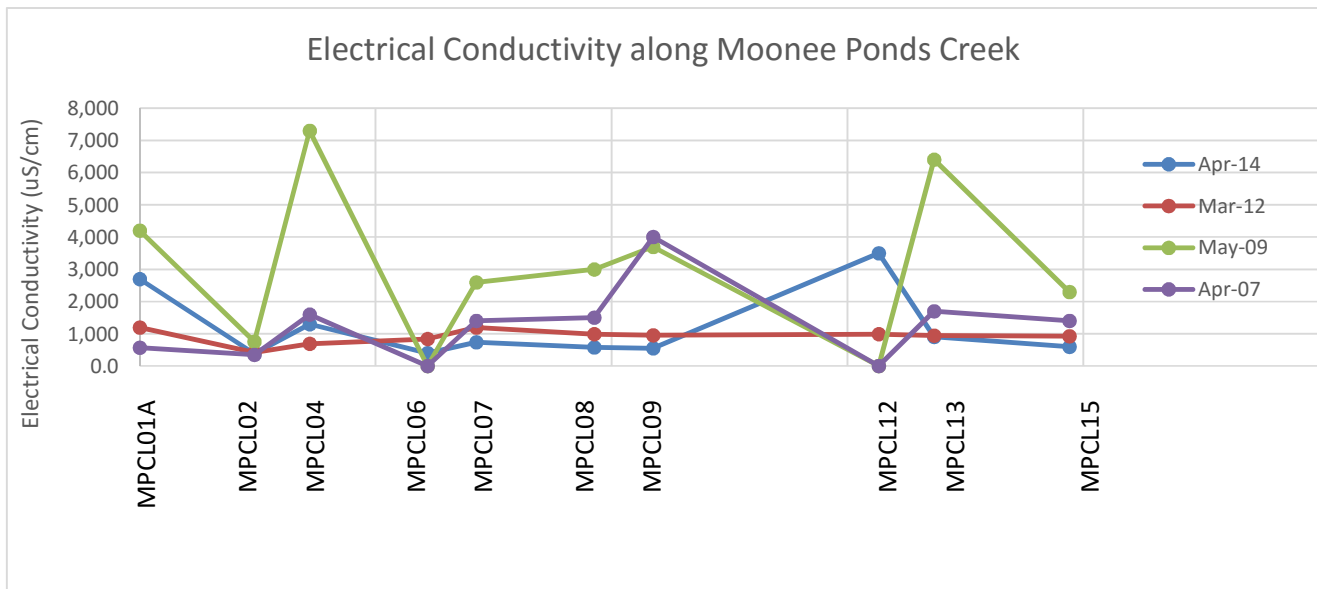
Chart 1: EC Along the MPC Profile

Electrical Conductivity measurements taken at approximate two year intervals for the monitoring locations along the Monee Ponds Creek profile are presented in **Chart 1** below:
